## Post Installation Report

HAGS - SMP

Longburrow Teen Area

Post Installation Report - 11 January 2016 at Inspector: Keith Dalton RPII Annual Inspector

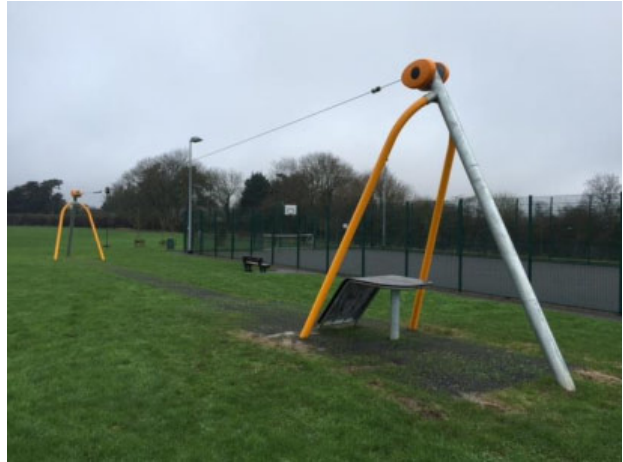
Finding 1

The cable and tensioning mechanism has now been fitted correctly - None required

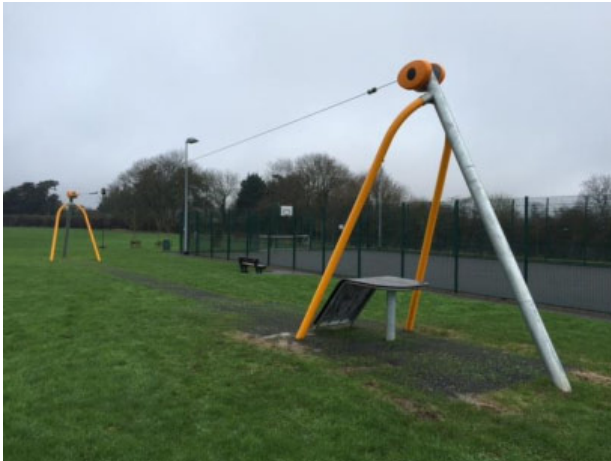
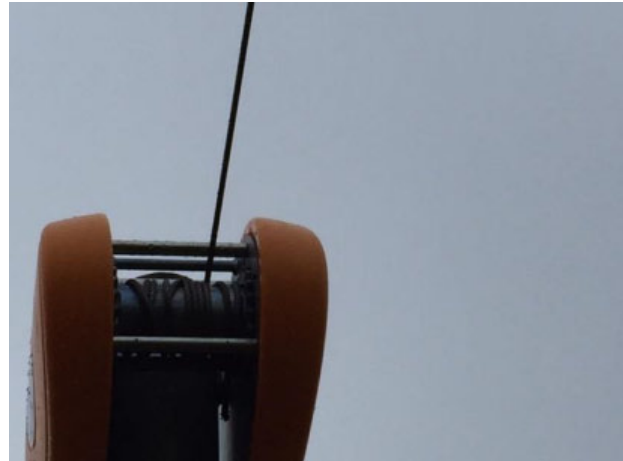
### 4 - Very Low Risk (Finding 1)

**Finding:** The cable and tensioning mechanism has now been fitted correctly

**Action:** None required
