## Post Installation Report

HAGS - SMP

Longburrow Teen Area

Park Lane, Stokenchurch, High Wycombe, Buckinghamshire,  
HP14 3TQ

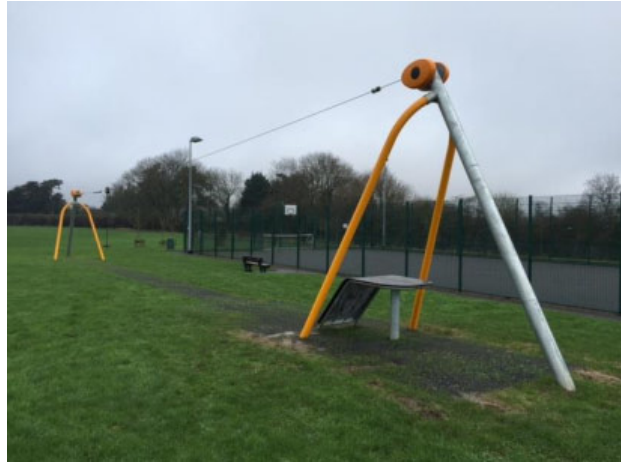
Finding 1

The cable and tensioning mechanism has now been fitted correctly - None required
